Anarchic occupation: Before and after study of the habitability of the Makasi cell in the town of Butembo in North Kivu/DR Congo

The urban fabric of the Makasi Cell, in the city of Butembo (North Kivu/DRC), is in a very advanced state of degradation. This comparative study before and after habitability sheds light on the direct impacts of housing occupation. To do this, GPS (Global Positioning System) coordinates and those related to the physical condition of buildings and roads were used. The GIS and remote sensing methods were chosen to highlight the slope class dedicated to the constructible zone and that related to the degradation of the fabric. The ground truth required field inspection before, during, and after rain scenes. It emerged that 40.07% of the surface area was in the 0–2% slope range. This low slope of the non-building zone exposes the Makasi Cell to the risk of flooding where it is considered a thalweg. After a rainy scene, the waters of the neighboring cells take the route into the Makasi Cell, the majority of which stagnates due to the configuration. On the other hand, after habitability, it results in 51.22% of buildings being in poor condition or in critical c

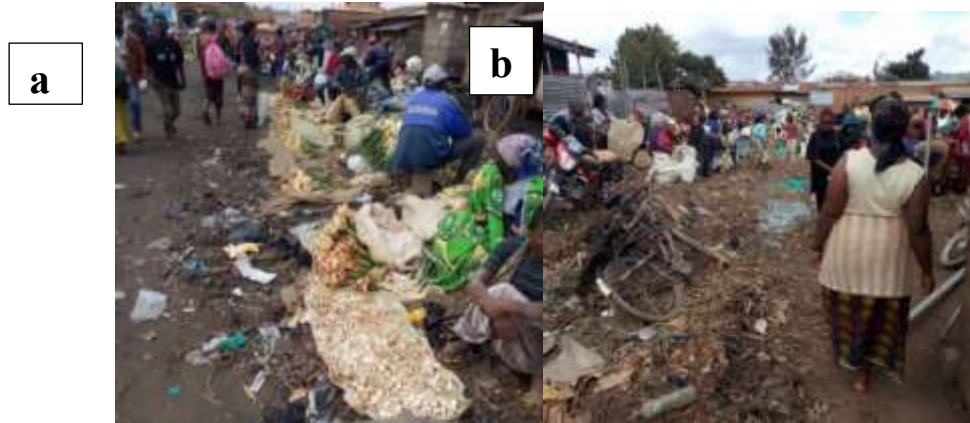
Figure 1. Overview of food sales on waste with poor condition, without display at Makasi market.

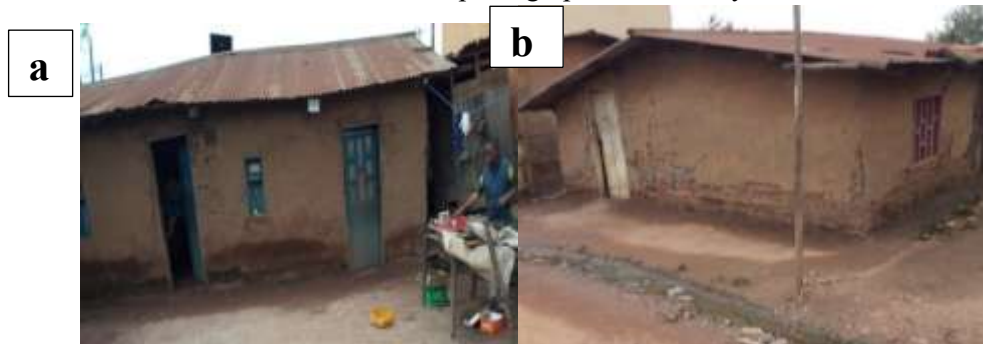
Figure 2. Overview of the subsidence of the buildings which are in a very advanced state of disrepair.

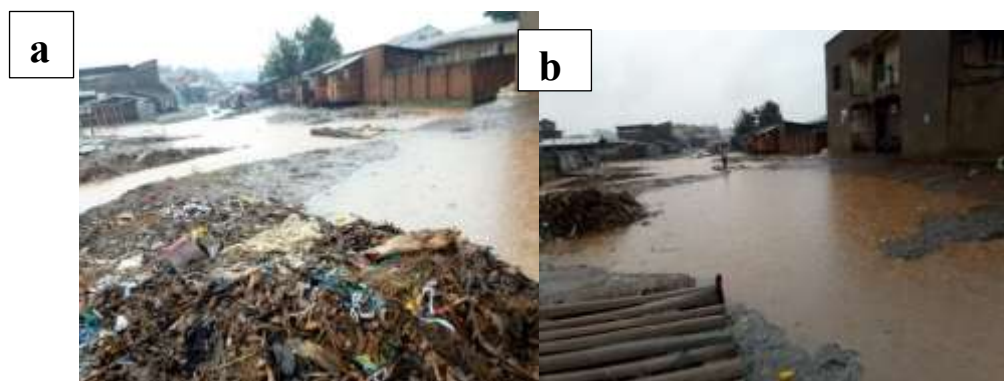
Figure 3. Overview of waste and flooding in the places often occupied by the Makasi market after a rain.

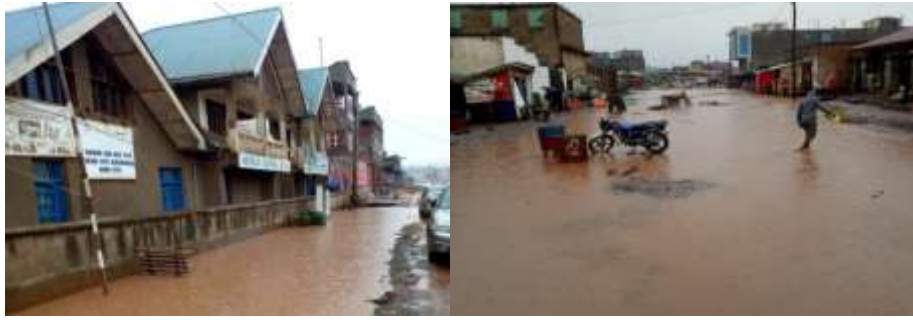
Figure 4. Overview of the state of the Butembo Health Zone office and the flooding of the squares occupied by the Makasi market.

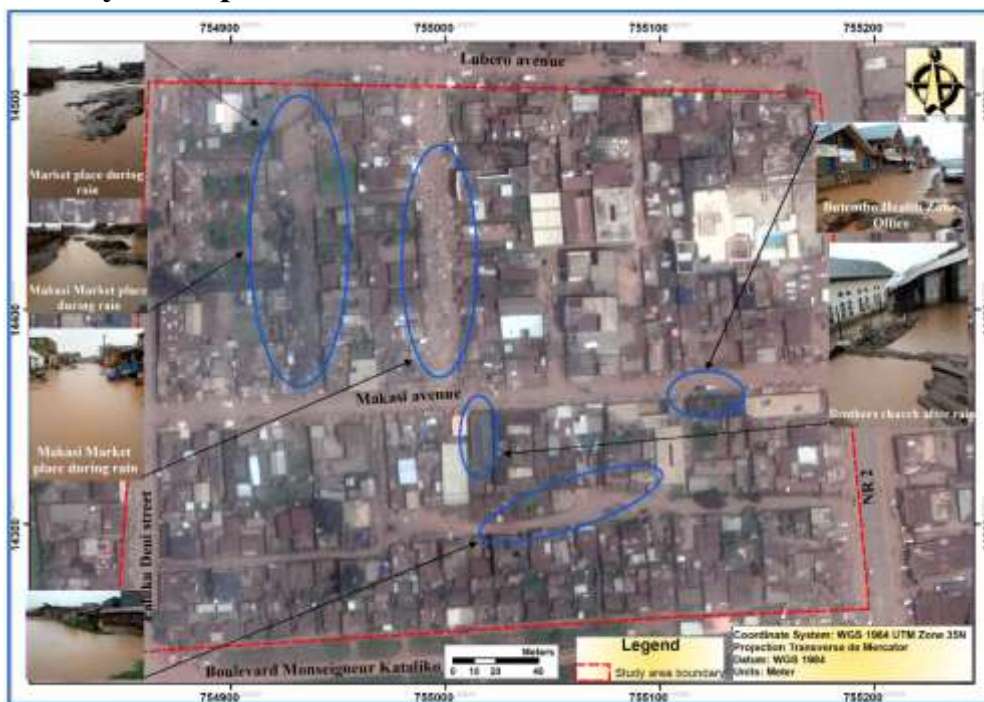
Figure 6. Analysis map of the Makasi Cell.

In this figure 6, some flooded areas have been circled and illustrated by photos taken in the rain at the occurrence of the market places of Makasi, the streets, the yard of the Central Office of the Butembo Health Zone.

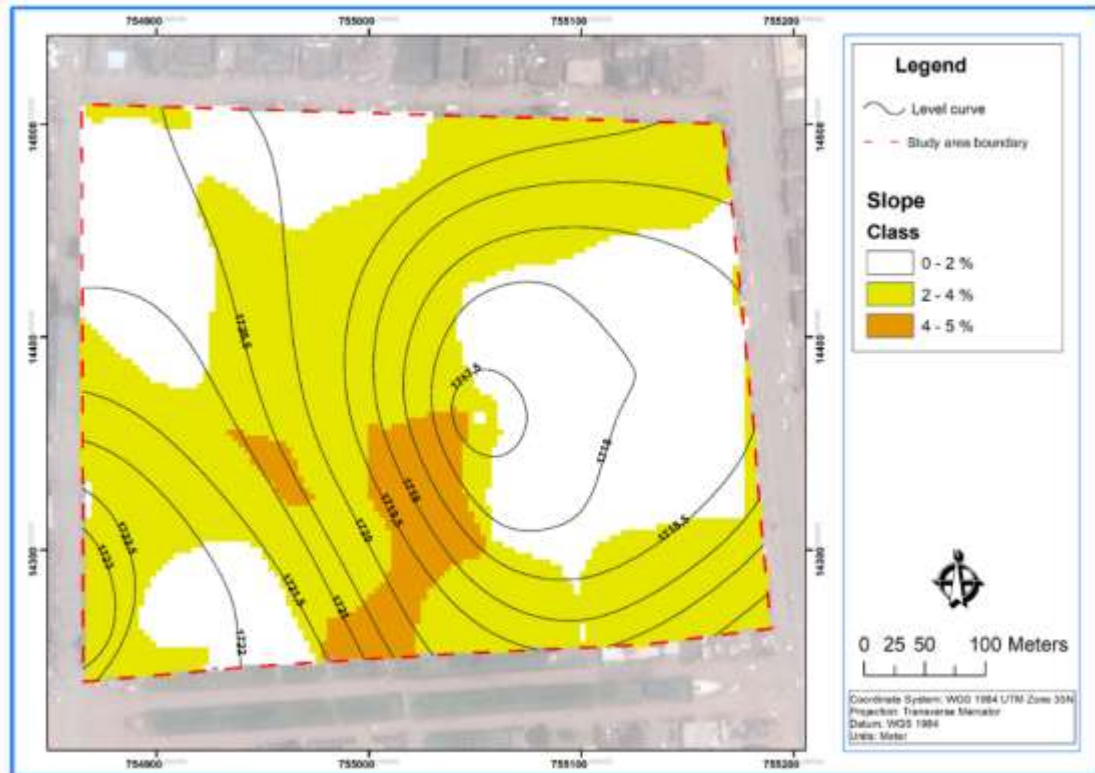
Figure 9. Slope map

Figure 9 shows the slope map of the Makasi cell. We can still observe from a general point of view, a predominance of slope class of 2-4% which represents 53.45%. While 40.07% of the surface is occupied by a slope class that varies between 0-2%. This last slope class is the one normally not buildable also called a non-building zone. And finally, we have a slope class that is between 4-8%. It represents 6.48% of the total surface area of the study site. These results attract the attention of researchers in the field of urban planning in order to each time take into account.

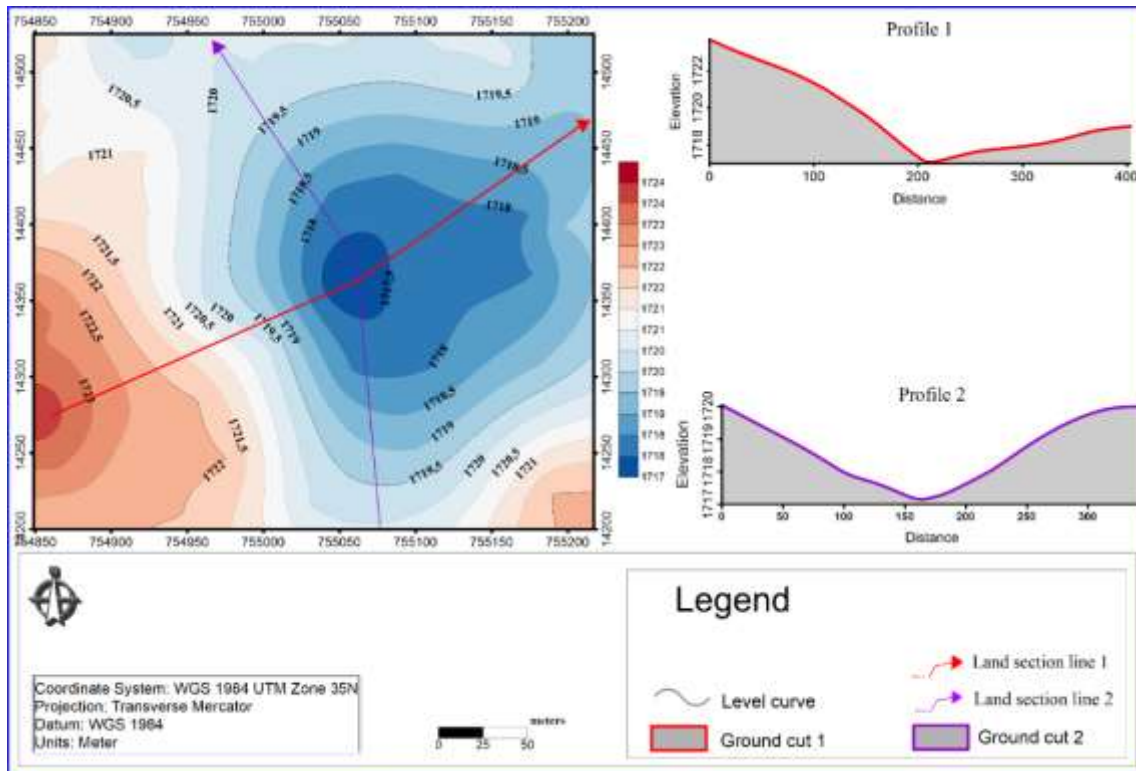
Figure 10. Terrain profile

From these two significant sections, the low level of the ground where rainwater stagnates emerges at their intersection. The first profile starts at an altitude of 1723 meters and goes through 1718 meters in altitude before this rainwater flows into the gutter of National Road number 2. The second profile, on the other hand, starts at 1721 meters in altitude, passing through 1717 meters up to 1721 meters in altitude. These profiles clearly show the areas of flooding.

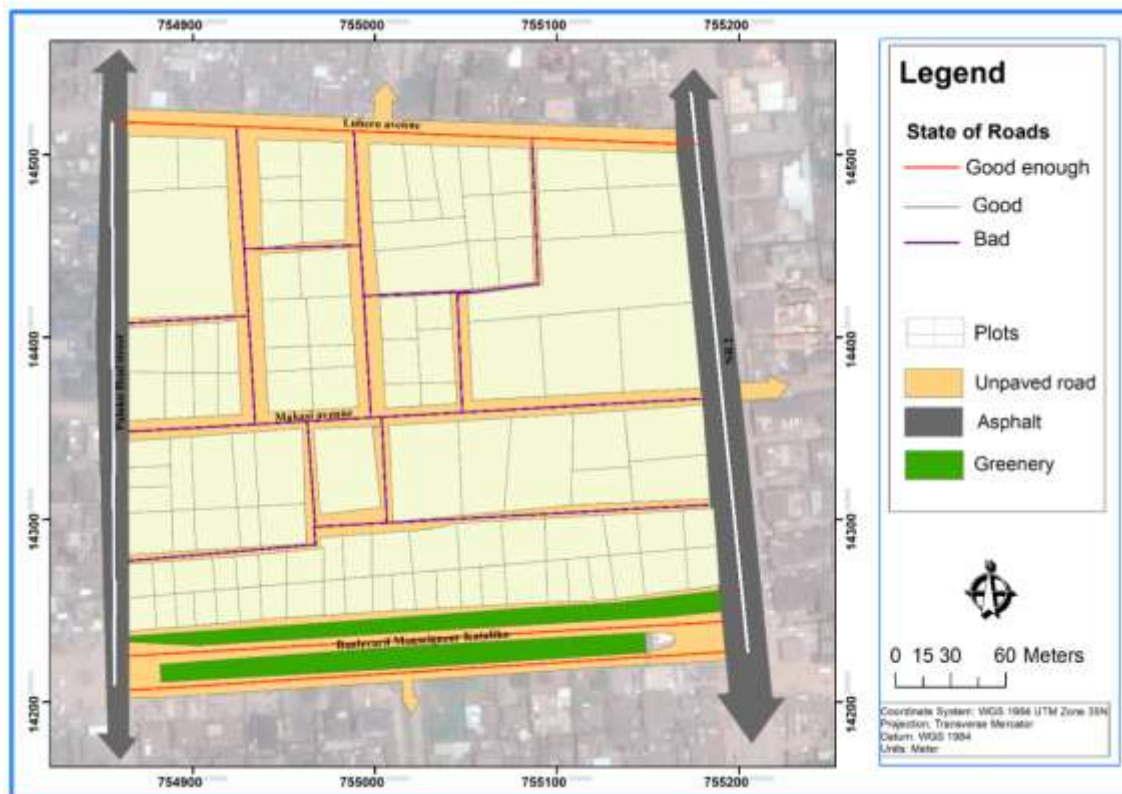
Figure 14. Physical condition map of the buildidings.

By reading Table 3, a total of 15 sections emerge. These 15 sections represent approximately 3,053 linear meters, or 3.053 kilometers. In light of these results, it is possible to determine the total cost of road rehabilitation for the Makasi Cell. The figures also provide a clear idea necessary to attract investors working in the road sector who can guide administrative authorities towards better decision-making.
